Manhole Inspection Summary

Manhole # S35CC1022MH

Insp Date: **11/30/06 12:17 PM**

Location Address: **326 SUFFOLK RD**

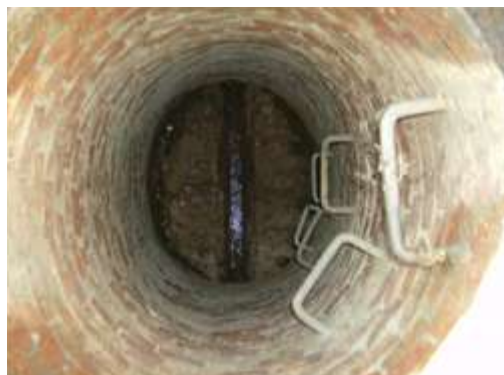
Top View

Adjustment and Barrel infiltration. Bench debris.

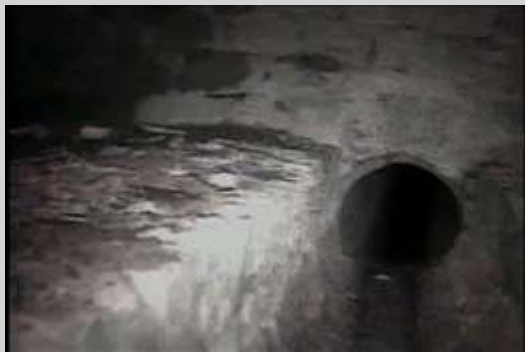
8 in. Circular Gravity Sewer Pipe Out @ 12 O'Clock

Infiltration: **Evidence** Pipe Seal Cond: **Unknown**

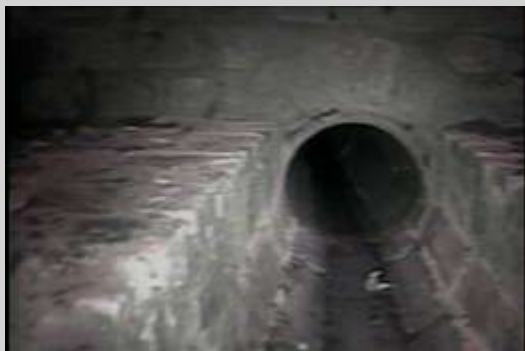
8 in. Circular Gravity Sewer Pipe In @ 6 O'Clock

Infiltration: **None** Pipe Seal Cond: **Unknown**
